GREENHOUSE

SCIENTIFIC DIRECTOR'S REPORT

ANNEX 8.1

BLAST EFFECTS ON AIRCRAFT IN FLIGHT

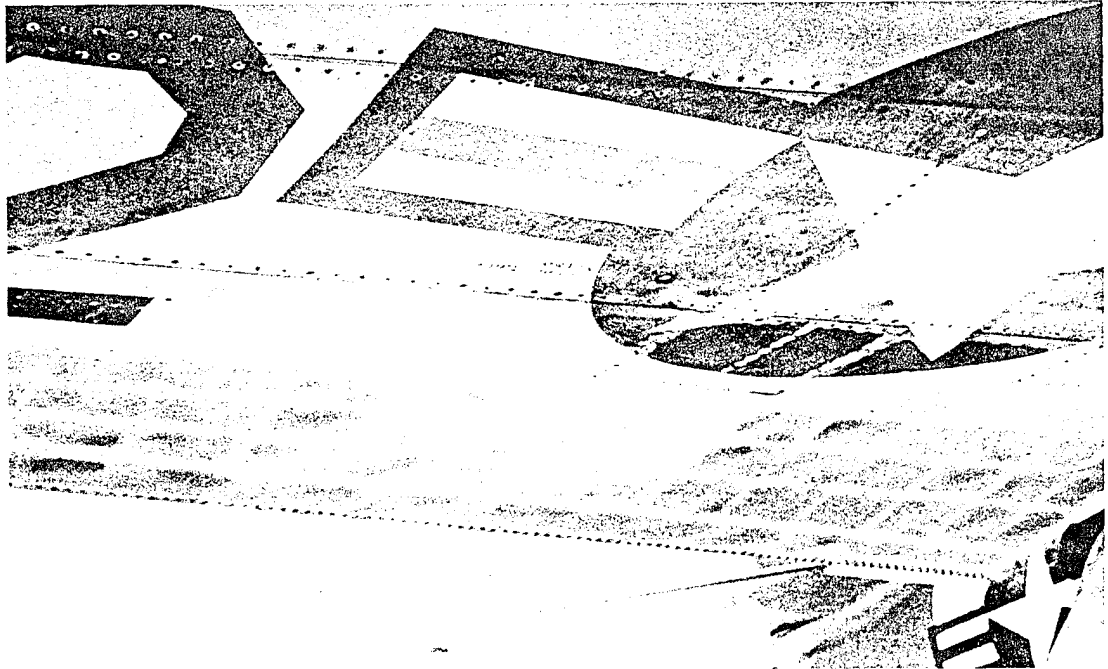
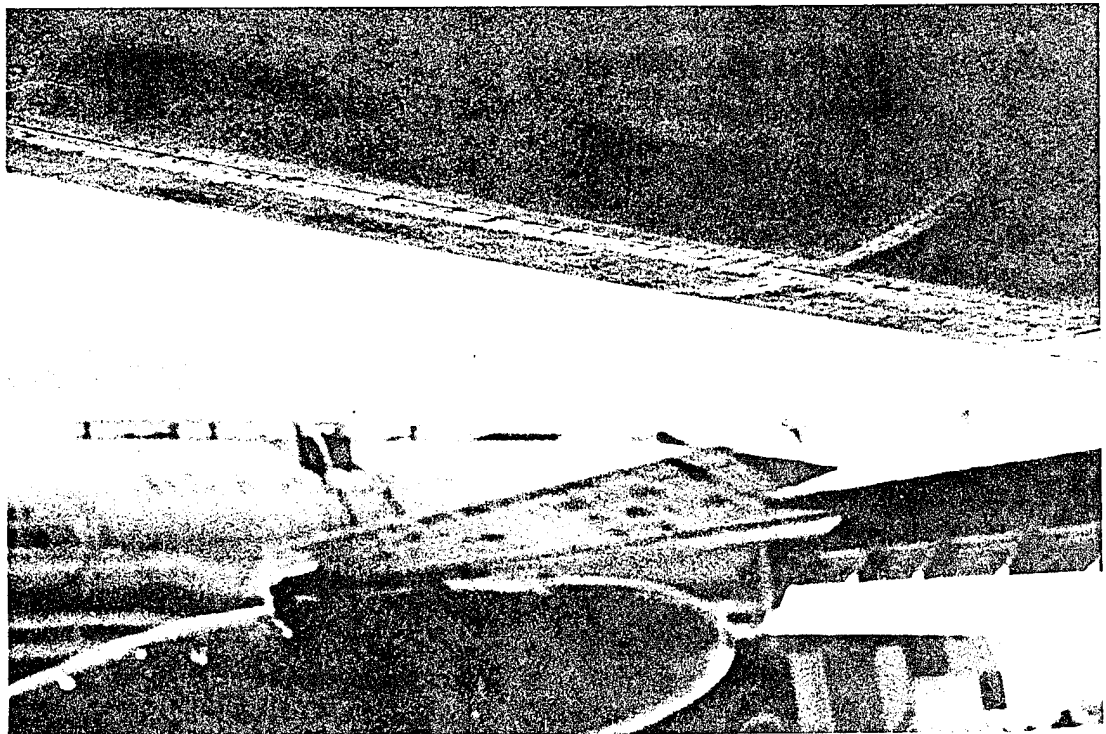
Fig. 5.1 Heat Damage to QT-33 No. 2, Dog Shot. (Above) right wing. (Below) aft fuselage.

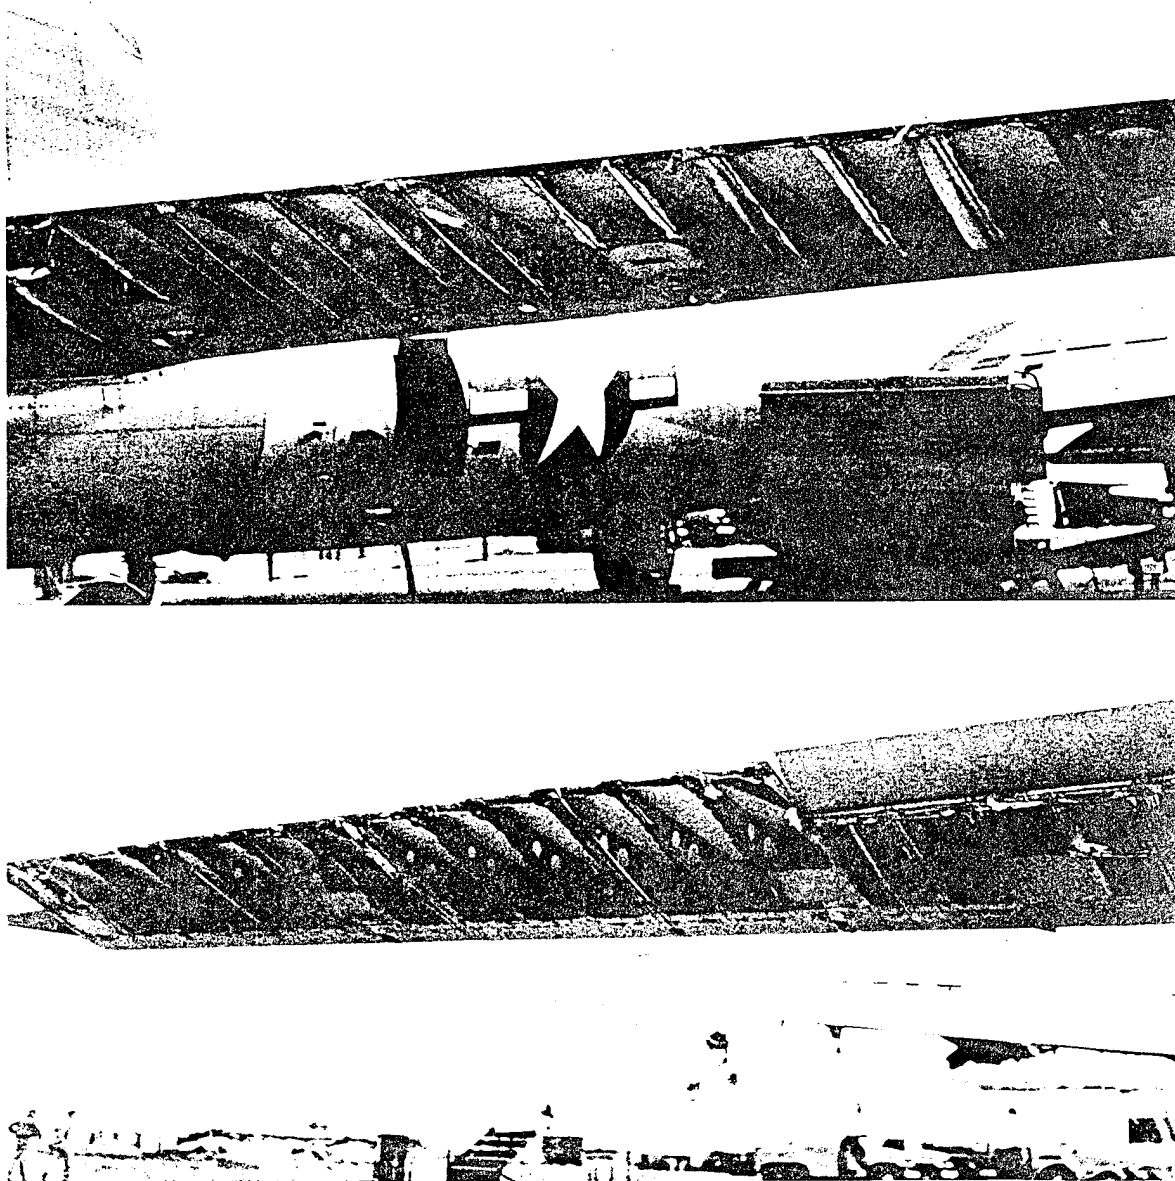
Fig. 5.19 Heat Damage to Elevators, QB-17 M, Dog Shot. (Above) right elevator. (Below) left elevator.

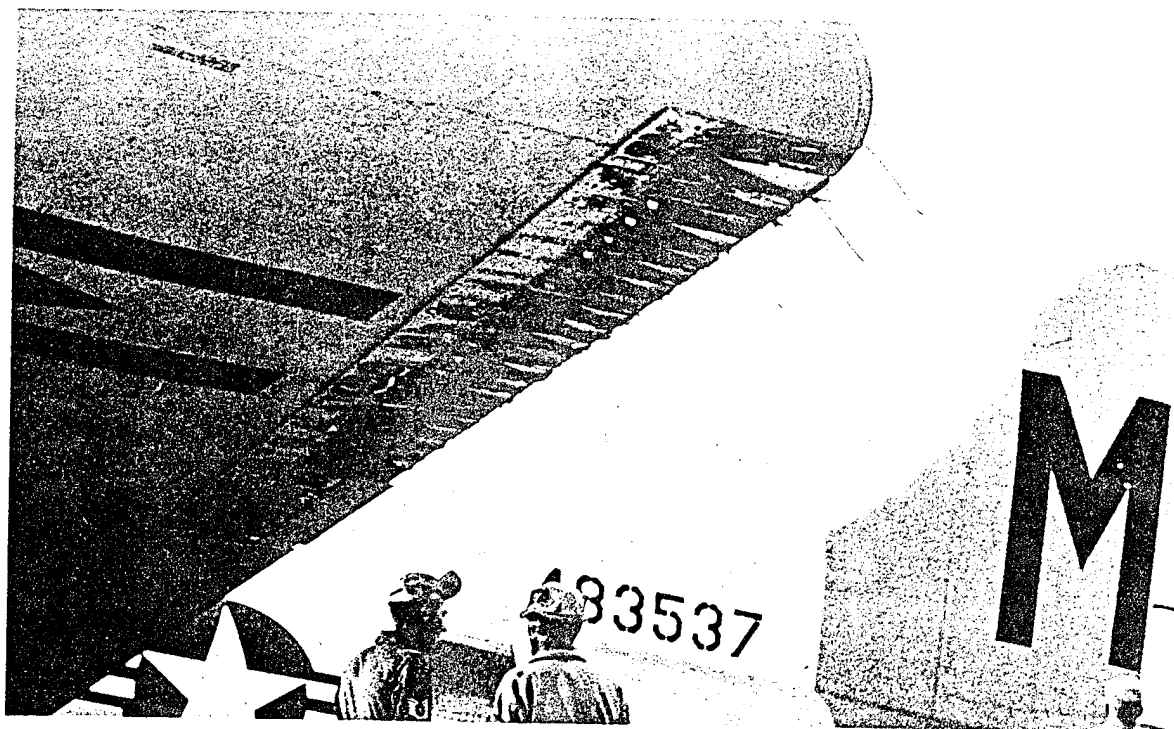
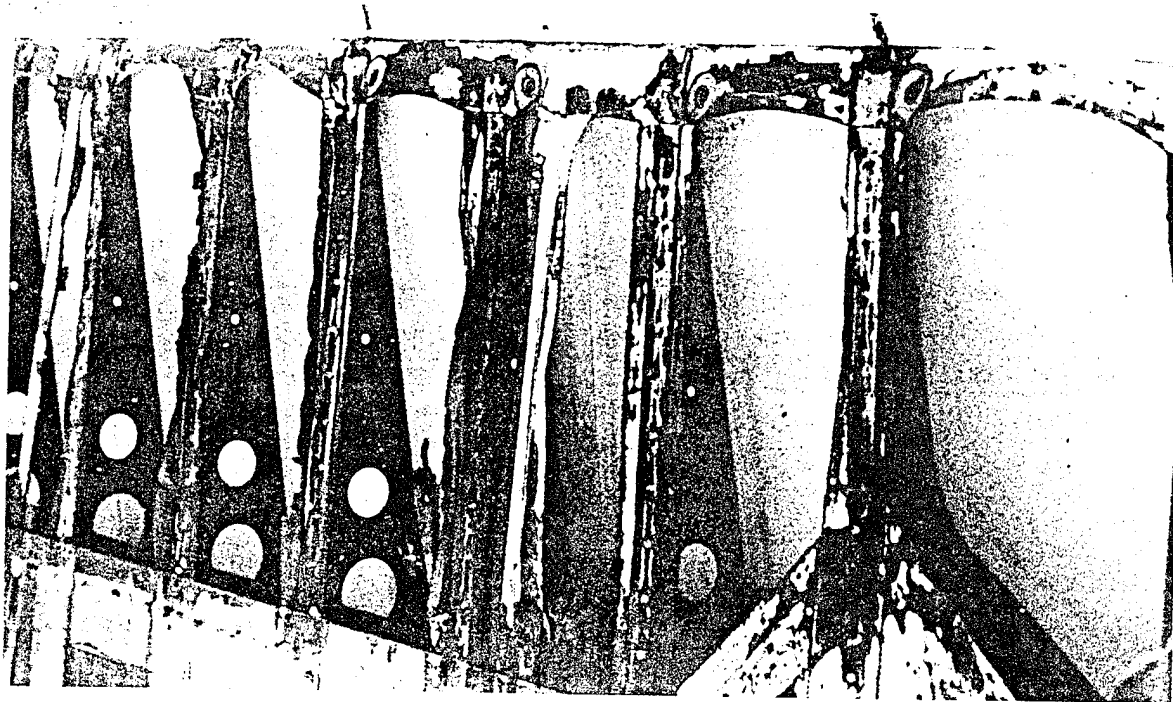
Fig. 5.20 Heat Damage to Ailerons, QB-17 M, Dog Shot. (Above) left wing and aileron. (Below) right aileron.

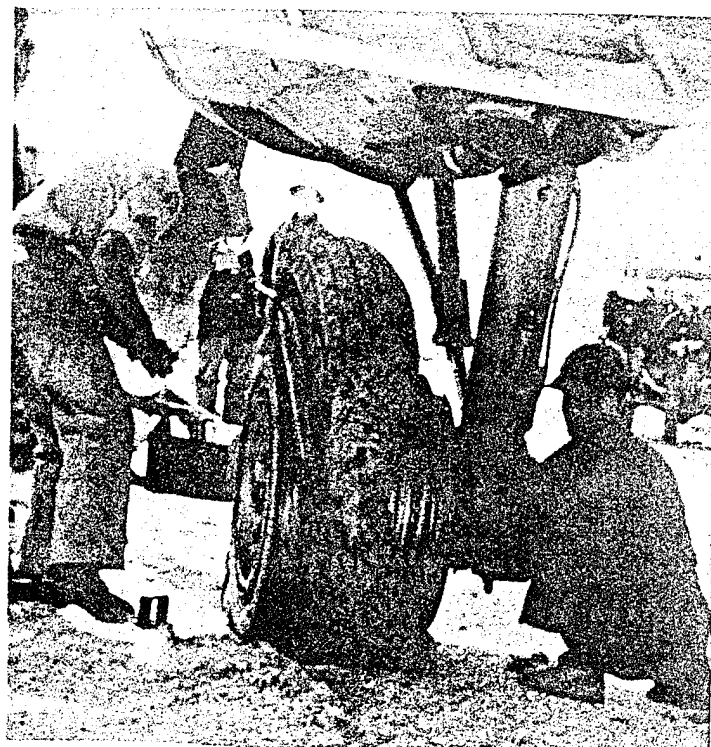
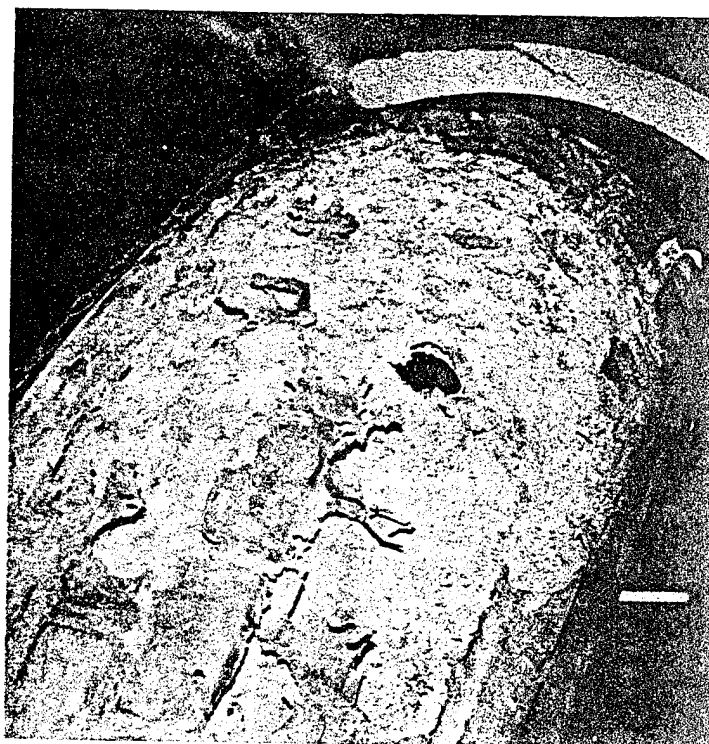
Fig. 6.16 Heat Damage to Tire, QB-17 Drone M, Easy Shot. A, tire and wheel. B, close-up of tire.

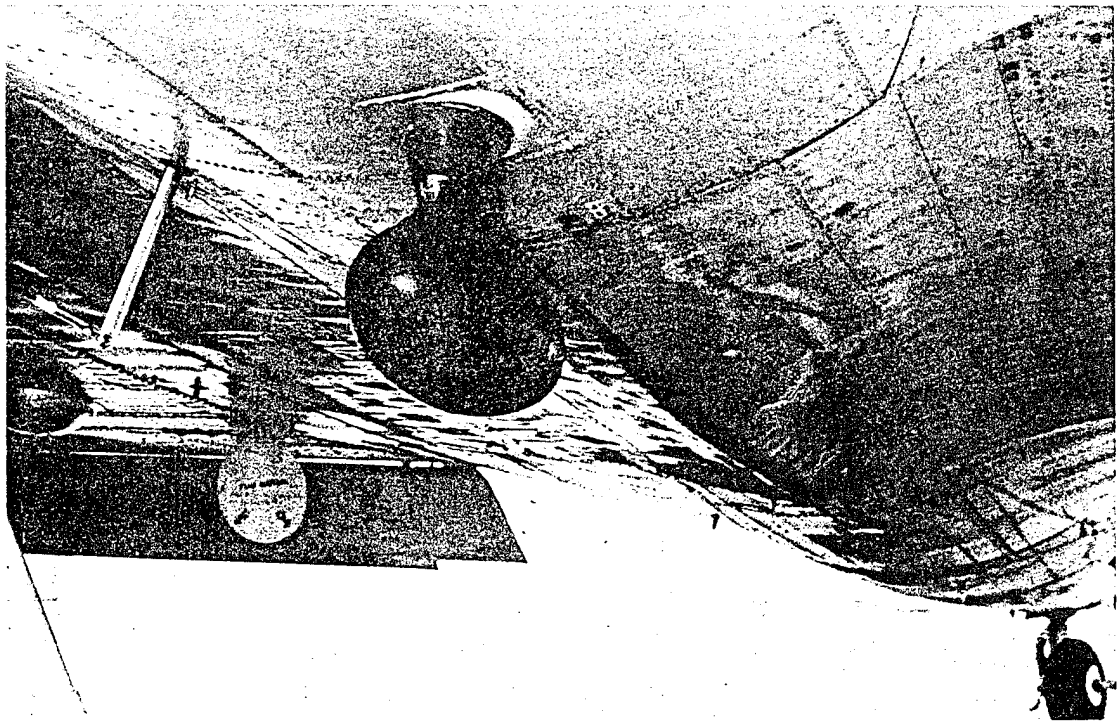
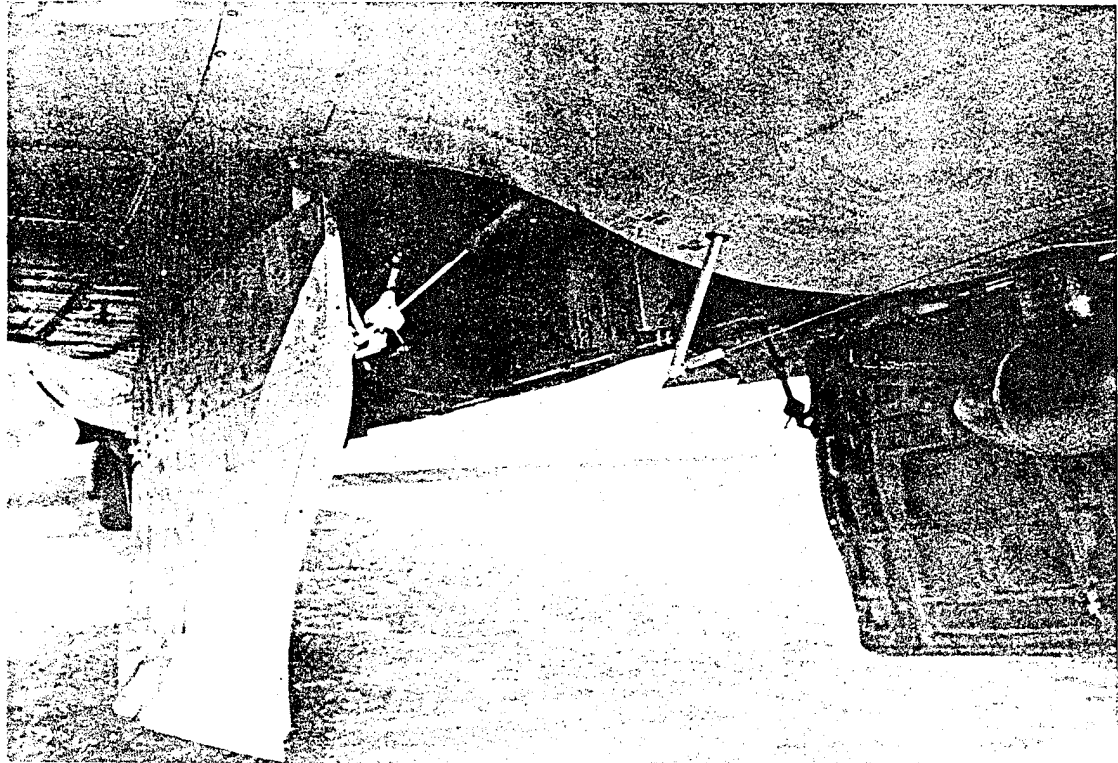
Fig. 6.17 Blast Damage to QB-17 Drone M, Easy Shot. (Above) bomb doors closed. (Below) bomb doors open.

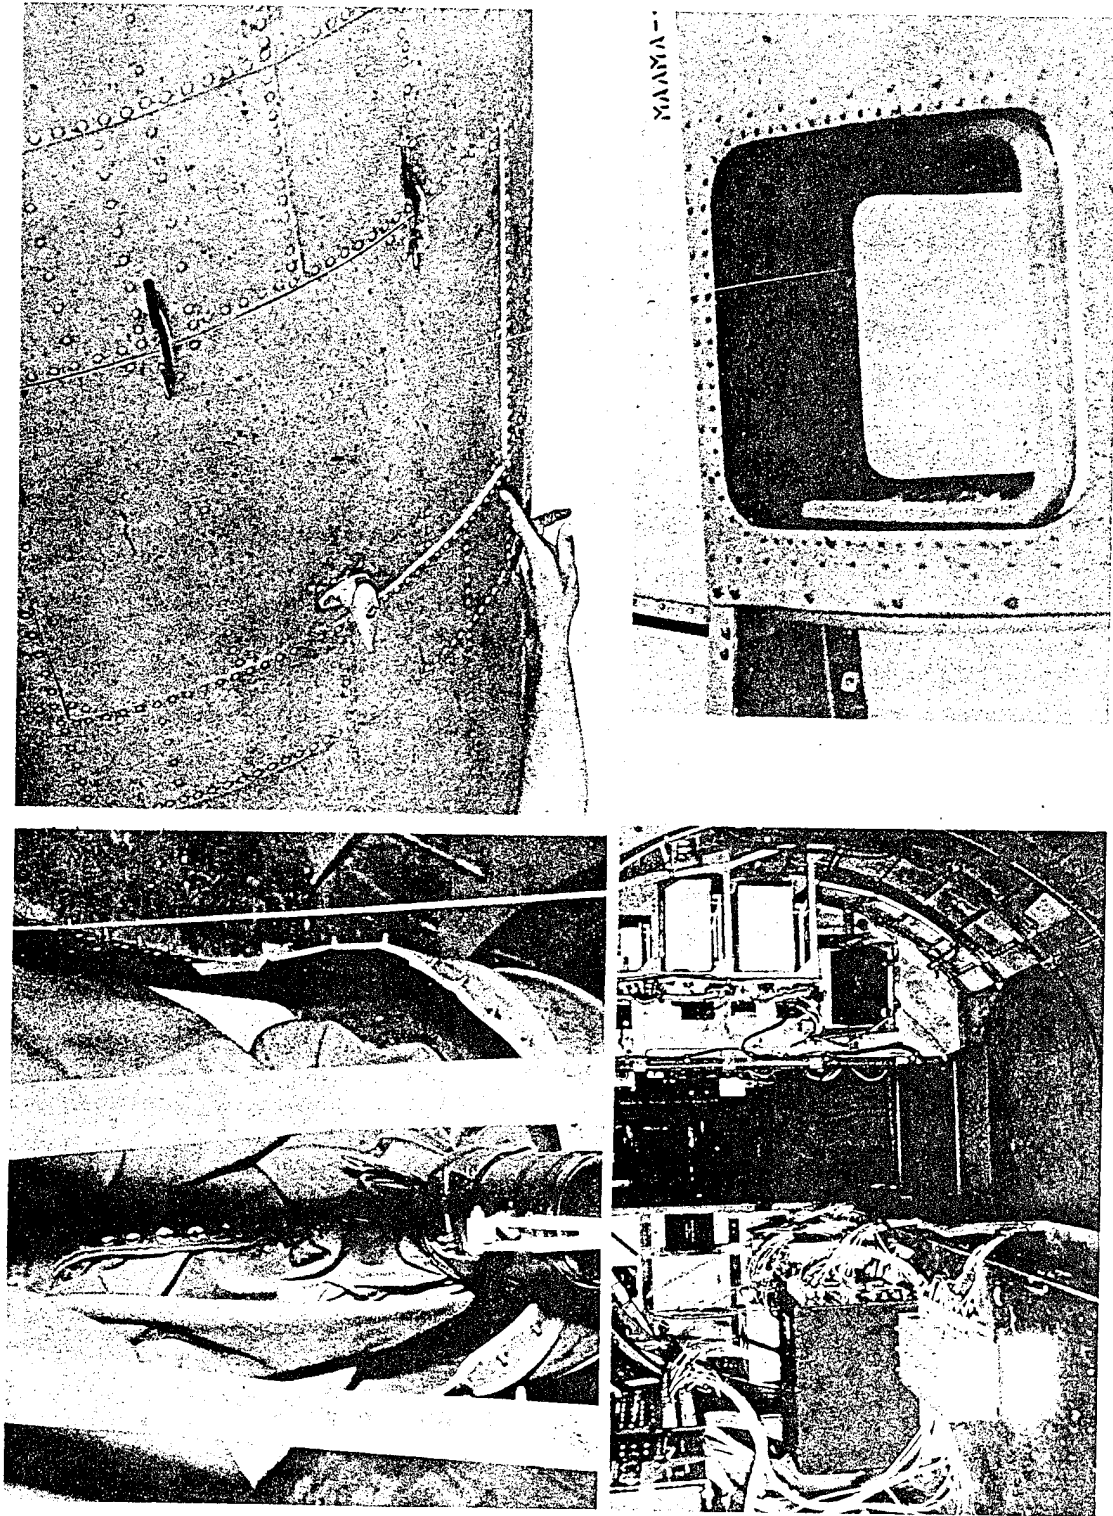
Fig. 6.18 Blast Damage to QB-17 Drone M, Easy Shot. (Upper left) tail-wheel-well cover blown out. (Upper right) entrance door sprung. (Lower left) radio-compartment floor boards blown in. (Lower right) tail-gunner's window blown in.

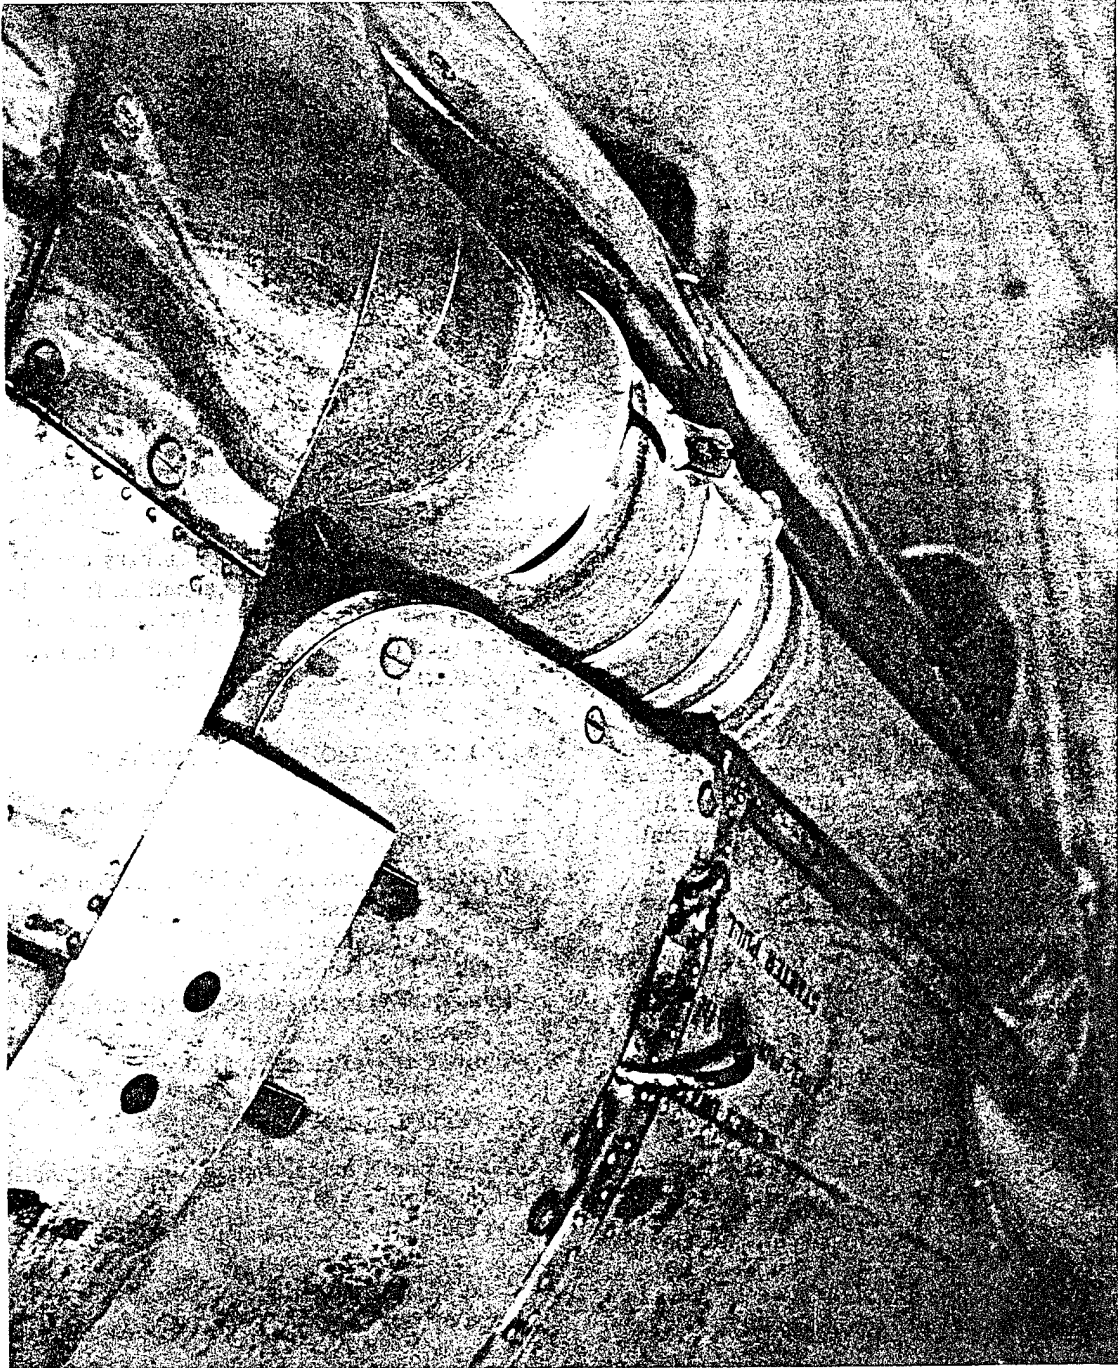
Fig. 6.19 Blast Damage to QB-17 Drone M, Easy Shot; Flexible Coupling of Exhaust Duct, No. 2 Engine

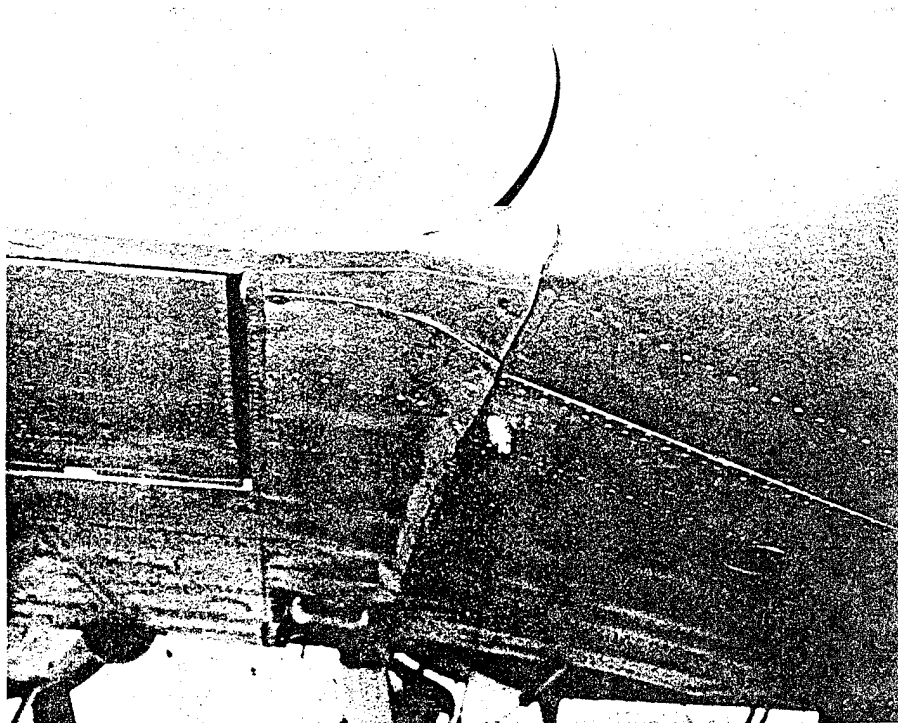
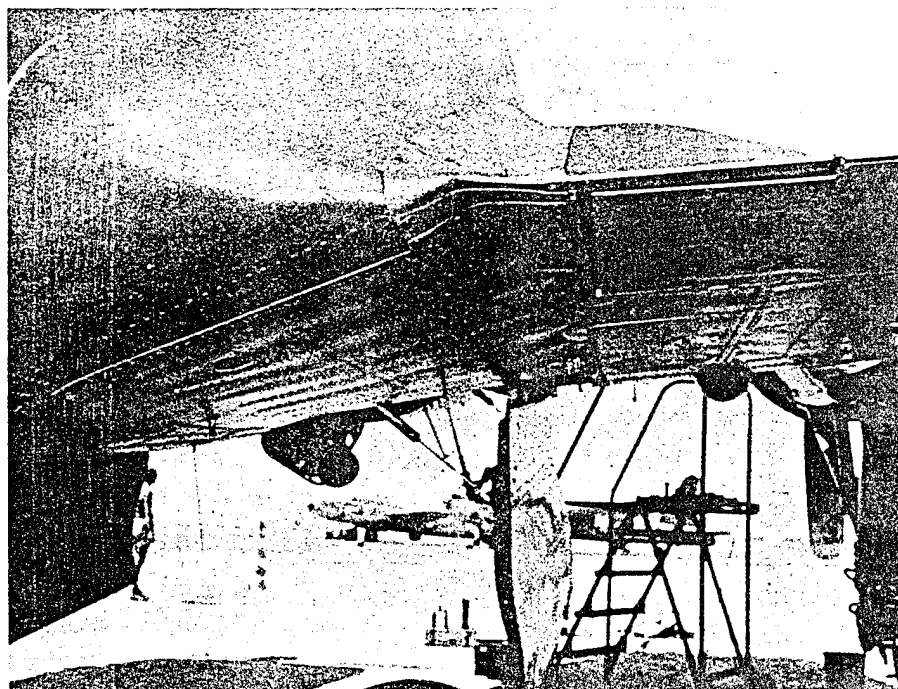
Fig. 6.34 Damage to QB-17 Drone N, Easy Shot. (Above) left wing root. (Below) right wing root.

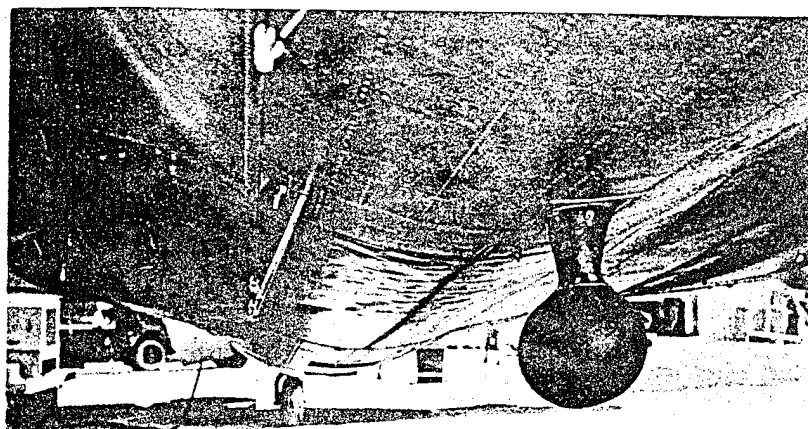
Fig. 6.35 Damage to QB-17 Drone N, Easy Shot. A, tear in wing-root fairing. B, close-up of wing-root fairing. C, damage to underside of fuselage.
